# **Evaluation of Freshwater Aquatic Resources and Stormwater Management at U.S. Naval Submarine Base, Bangor, Washington**

by Christopher W. May

Technical Memorandum  
**APL-UW TM6-97**  
December 1997

**Applied Physics Laboratory University of Washington**  
1013 NE 40th Street Seattle, Washington 98105-6698

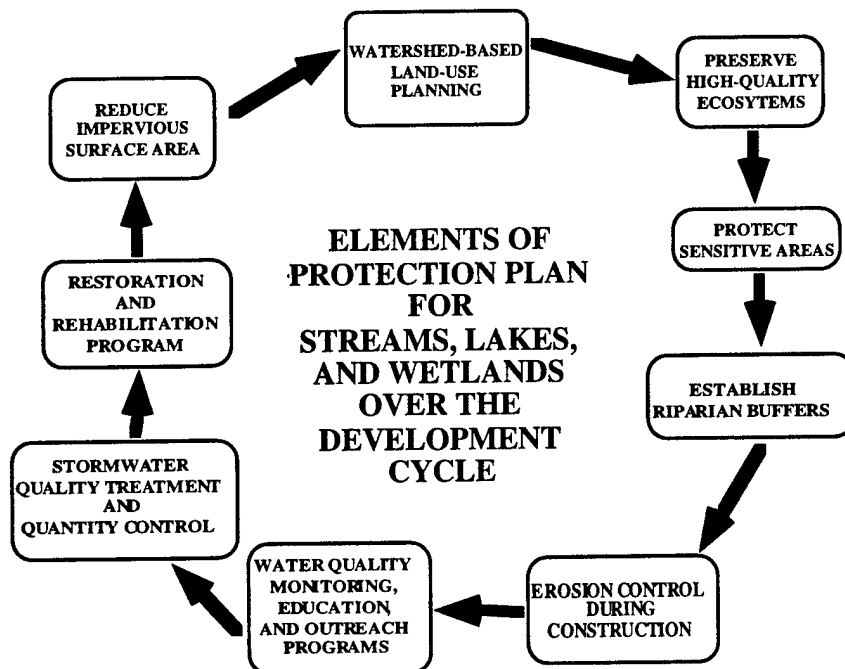
**Figure 1.** Key elements of a watershed-based protection strategy for aquatic resources (Schueler, 1995).

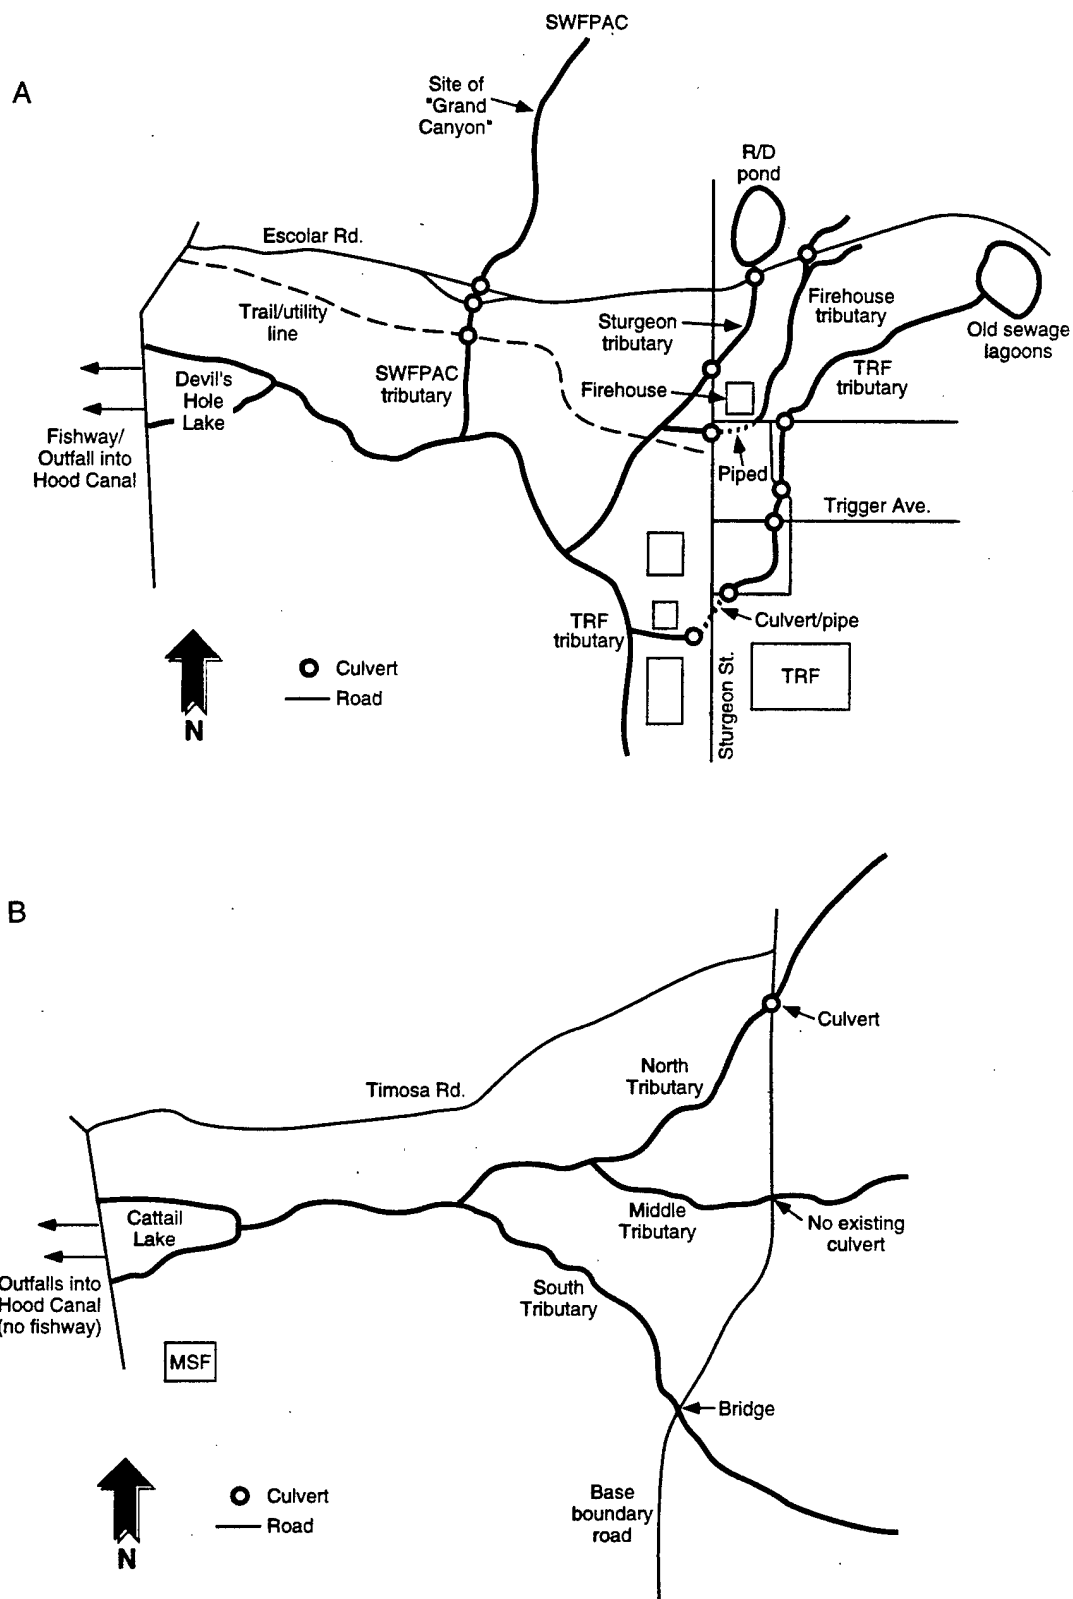
**Figure 4.** Map of NSB-Bangor subbasins. A. Devils Hole Creek. B. Cattail Creek. (The Clear Creek subbasin has been omitted, as only its headwaters are on the base.)

The Naval Submarine Base, Bangor, comprises 6,785 acres, over 50% of which are undeveloped, natural forested areas, and includes three small-stream watersheds (Figure 4). Stormwater treatment facilities include both natural conveyances (streams and wetlands) and constructed conveyances (swales, ditches, and culverts), as well as retention and detention facilities. Most stormwater runoff is infiltrated and/or treated by engineered facilities prior to entering the natural surface-drainage network. All stormwater is treated prior to leaving NSB-Bangor boundaries. Stormwater treatment ponds provide for sedimentation and limited removal of NPS pollutants. Each R/D facility includes an oil/water separator at the inlet of the pond. The main stormwater treatment ponds are

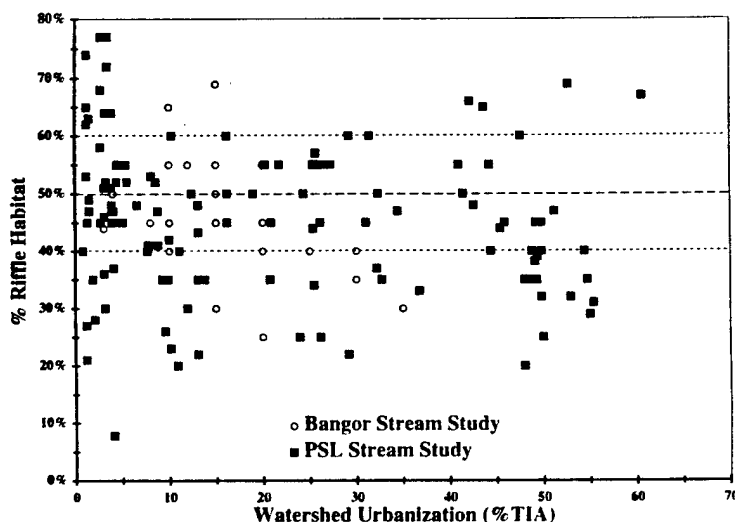
**Figure 5.** Salmonid spawning habitat (riffles) in NSB-Bangor streams compared with that found in other Puget Sound lowland (PSL) streams during a recent study (May, 1996). Spawning habitat (riffles) should comprise 40–60% of the wetted surface area of the stream (Peterson et al., 1992).

In general, the quantity of salmonid spawning habitat (riffles and pools) in NSB-Bangor streams appears to be adequate. For low-gradient ( $<4\%$ ), pool/riffle streams like those found in the Puget Sound lowland region, spawning (riffle) habitat should comprise about 50% (40–60%) of the wetted surface area of the stream (Peterson et al., 1992). For the streams located within NSB-Bangor, all but one section of Devils Hole Creek (the TRF reach) is between 40% and 60% riffles. The upper segment of the middle branch of Clear Creek just outside the NSB-Bangor boundary (downstream of the PW stormwater pond) also lacks spawning habitat. A comparison of NSB-Bangor stream segments with those surveyed during a recent study of PSL streams shows that the NSB-Bangor streams have comparable fractions of spawning habitat (Figure 5). The quantity (surface area) of spawning habitat in PSL streams was found to be adequate for all levels of land usage.

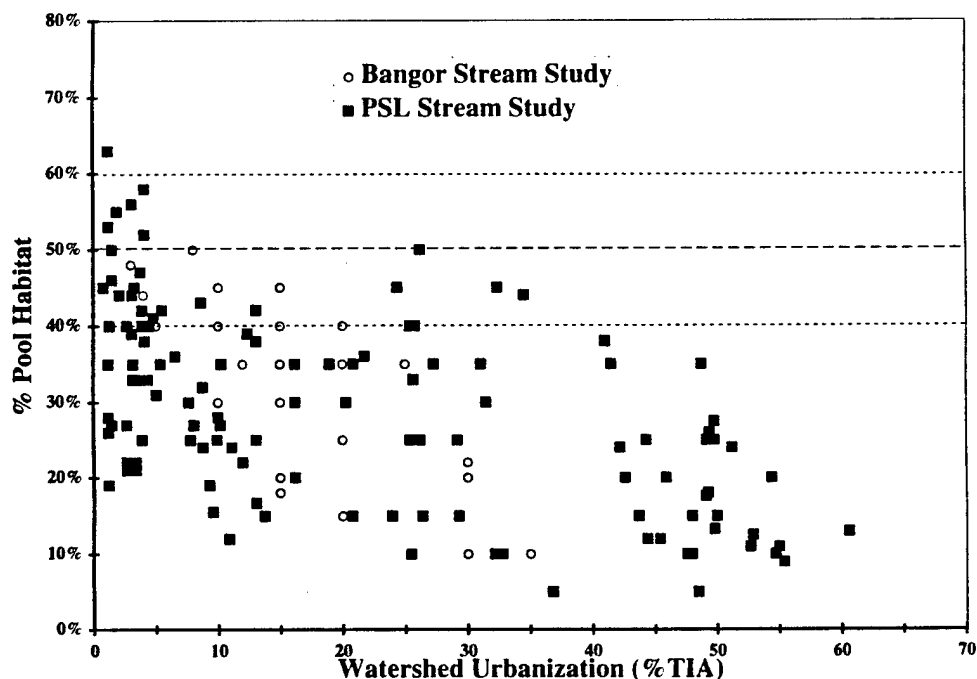
**Figure 6.** Salmonid rearing habitat (pools) in NSB-Bangor streams compared with that found in other Puget Sound lowland (PSL) streams during a recent study (May, 1996). Rearing habitat (ponds) should comprise 40–60% of the wetted surface area of the stream (Peterson et al., 1992).

The fraction of total stream area that was classified as pool habitat (Figure 6) decreased as subbasin development increased, both in the PSL stream study and in the NSB-Bangor stream study. At the same time, the fraction of stream area in riffles (Figure 5) did not significantly change as subbasin development increased. Instead, there was a shift from a "balanced" pool/riffle morphology to a glide-dominant morphology. Glides are intermediate habitats that have characteristics of both pools and riffles but few of the functional attributes of either, providing little cover or flow refuge.

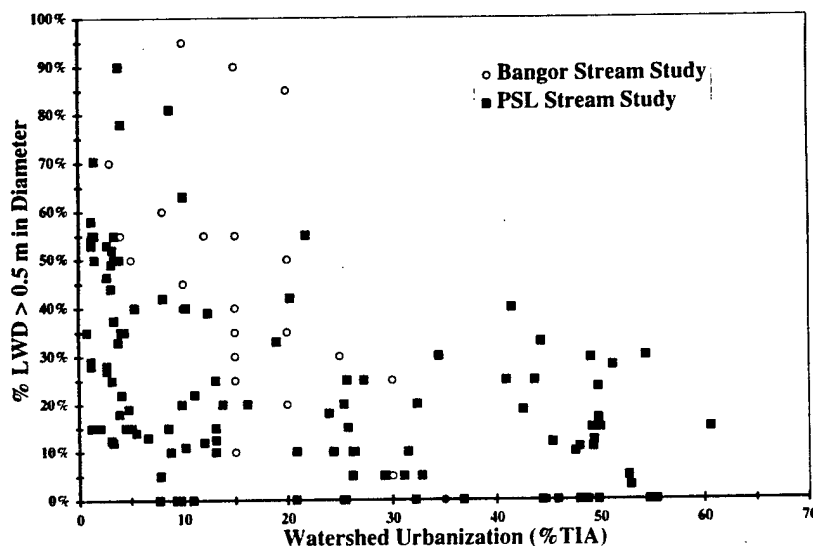
**Figure 9.** Percentage of key (>5-m-diameter) large woody debris (LWD) in NSB-Bangor streams compared with that in other Puget Sound lowland (PSL) streams (May, 1996).

urban streams, where large flows occur more frequently. In the PSL study, on average, 40% of the LWD in reference stream segments was >0.5 m in diameter (May, 1996). In comparison, a recent study of streams in unmanaged forests (Ralph et al., 1994) found that, on average, 60% of the LWD was >5 m in diameter. That same study found that, on average, about 40% of the LWD in streams in managed (logged) forests was >5 m in diameter. In this respect, the PSL reference streams (%TIA < 5%) appear to be comparable to forest streams with timber being harvested in their watershed. In urbanized PSL streams, on the other hand, only 20% of the total LWD was in the key size range, indicating a more significant loss of "key" LWD due to urbanization than due to logging. Other measures of LWD quality include the type (coniferous or deciduous), the species (cedar is considered best), and the age of the wood.

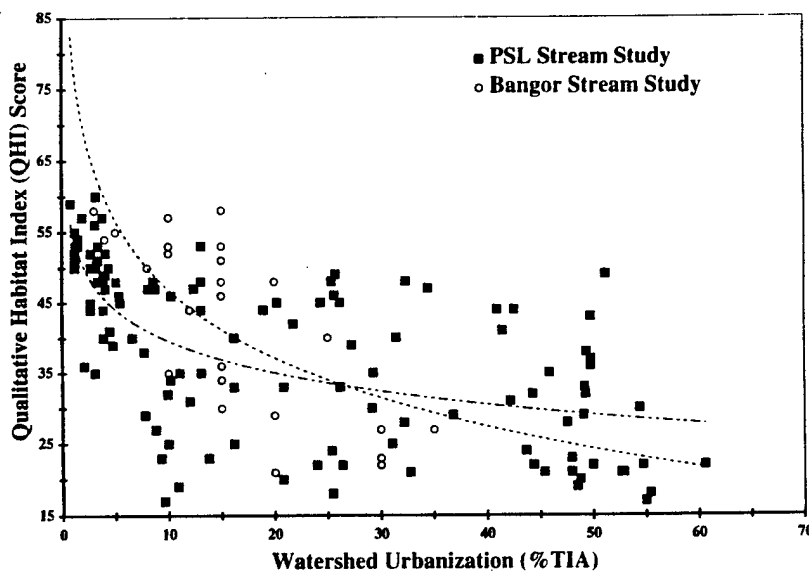
**Figure 10.** Qualitative habitat index (QHI) scores for NSB-Bangor streams compared with those for other Puget Sound lowland (PSL) streams.

Figure 10 compares the QHI scores of NSB-Bangor streams and other PSL streams. As with several of the quantitative habitat measures (LWD, pools, and riffles), the QHI scores suggest that there is an initial dramatic decline in habitat quality as basin development (%TIA) increases above 5–10%. In other words, the effects of human intrusion on the stream ecosystem become evident even during the subtle shift from largely undeveloped to rural watershed land use. A similar precipitous decline in habitat quality is often seen for other land-use activities, timber harvesting being the most notable. Pin pointing the exact stressors responsible for this drop in habitat quality is difficult; however, a multimetric index such as the QHI is able to detect this change because of its assessment of several variables. The QHI is also able to differentiate between the "best" and "worst" stream segments and as such provides a useful first-cut tool for assessing stream quality. That the QHI results for the mid-range of basin development (suburban) were quite variable should not be surprising. The complexity of stream systems and the variety of impact variables make accurate assessment difficult, on either a quantitative or a qualitative basis.

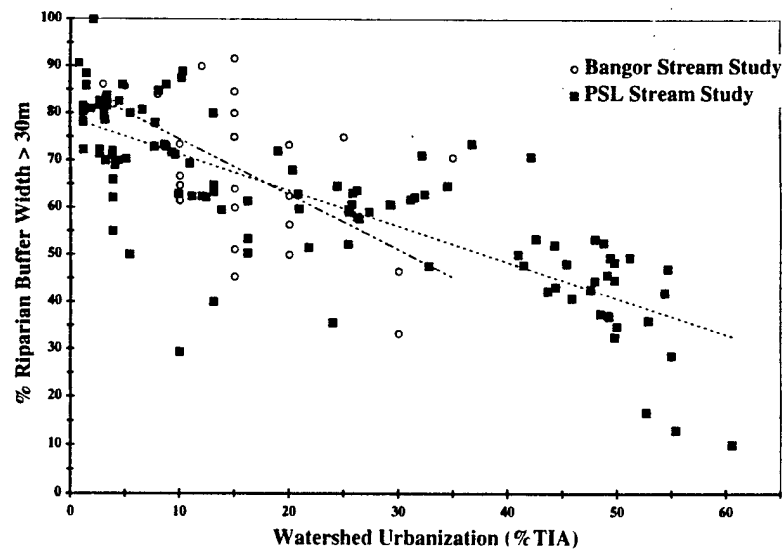
**Figure 11.** Riparian buffer integrity in NSB-Bangor study streams compared with that in other Puget Sound lowland (PSL) streams (May, 1996).

Each segment of the riparian buffer was also examined qualitatively based on the dominant land use within 30 m of the stream. Mature forest, young forest, and wetlands were considered "natural" land use as opposed to predominantly residential or commercial use. From an ecological perspective, mature forest and/or riparian wetlands are the two most desirable natural riparian conditions (Gregory et al., 1991). Figure 13 compares the percentage of riparian corridor in NSB-Bangor and other PSL watersheds that is composed of forest or riparian wetland. Only in the undeveloped reference streams (%TIA < 5%) is most of the riparian corridor in a natural condition. In addition, no urbanized streams have retained more than 25% of their natural floodplains.

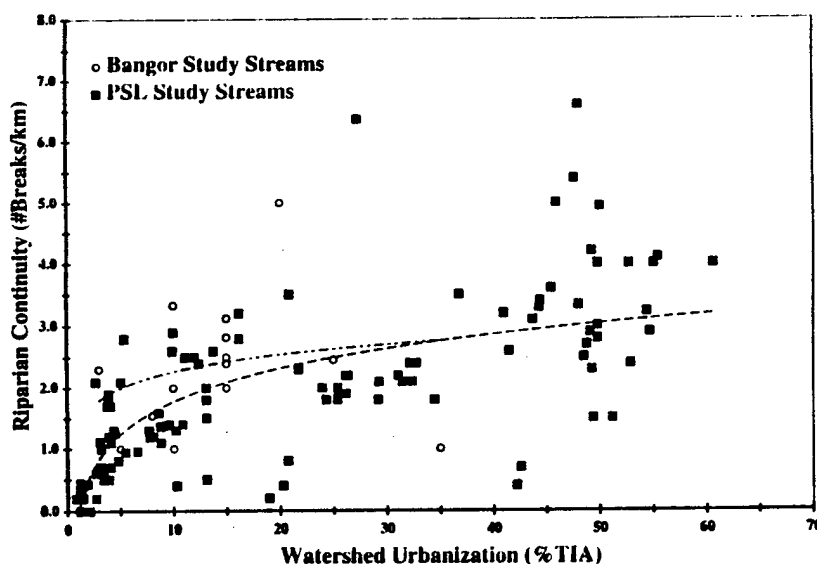
**Figure 14.** Riparian corridor continuity in NSB-Bangor streams compared with that in other Puget Sound lowland (PSL) streams (May, 1996).

As a measure of the longitudinal continuity of the riparian corridor, the number of breaks in the riparian zone was tallied for each stream segment surveyed. Breaks, for the purpose of this study, were considered such things as road crossings, pipelines, and utility right-of-ways. The number of breaks was normalized to a per kilometer basis using stream segment length for comparison purposes. There was a strong, direct relationship between breaks (per kilometer) in the riparian corridor and urbanization level (see Figure 14). In

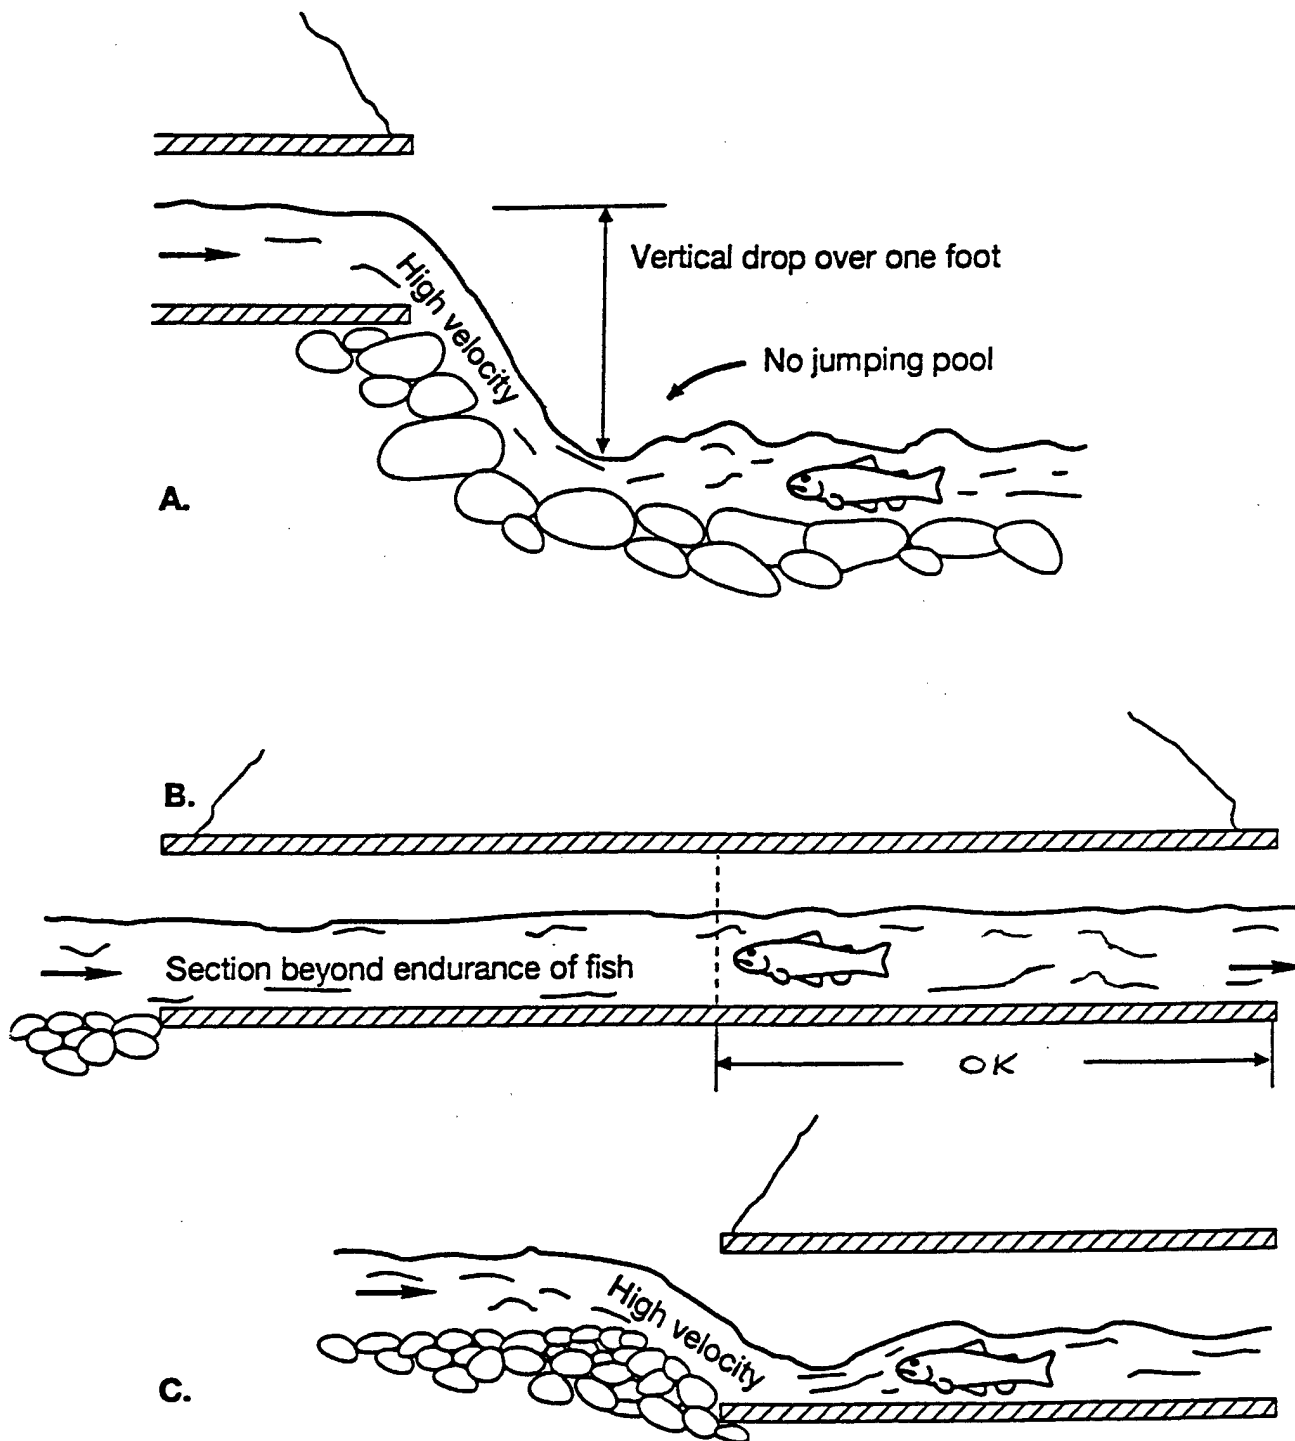
**Figure 15.** Culvert passage problems (from Evans and Johnston, 1980). A. Perched culvert. B. Culvert length beyond endurance of fish. C. Culvert inlet velocity too high.

- an excessive drop at the culvert's outlet (so-called "perched" culverts)
- too high a velocity at the culvert's inlet (fish unable to exit)
- depth and/or velocity problems within the culvert during flow extremes
- accumulation of debris at the culvert's inlet (inadequate capacity)
- misalignment of the culvert with respect to the stream channel
- too long a culvert (beyond the endurance of the fish)
- culverts installed at too steep a gradient (resulting in high flows)
- culverts with no resting pools at inlets or outlets
- stream-bank erosion, scouring, and deposition due to poor culvert road fill.

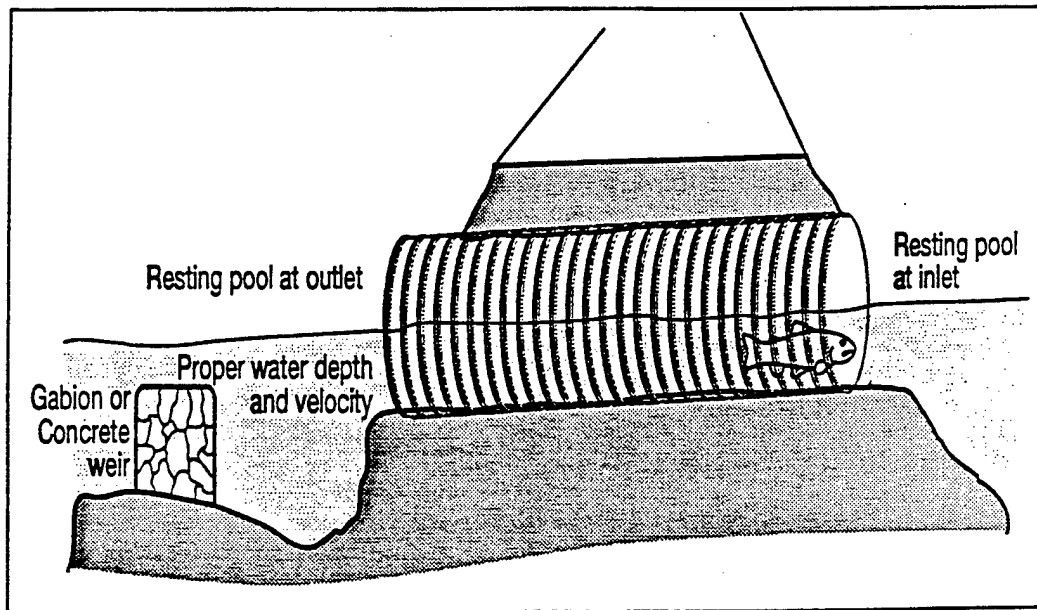
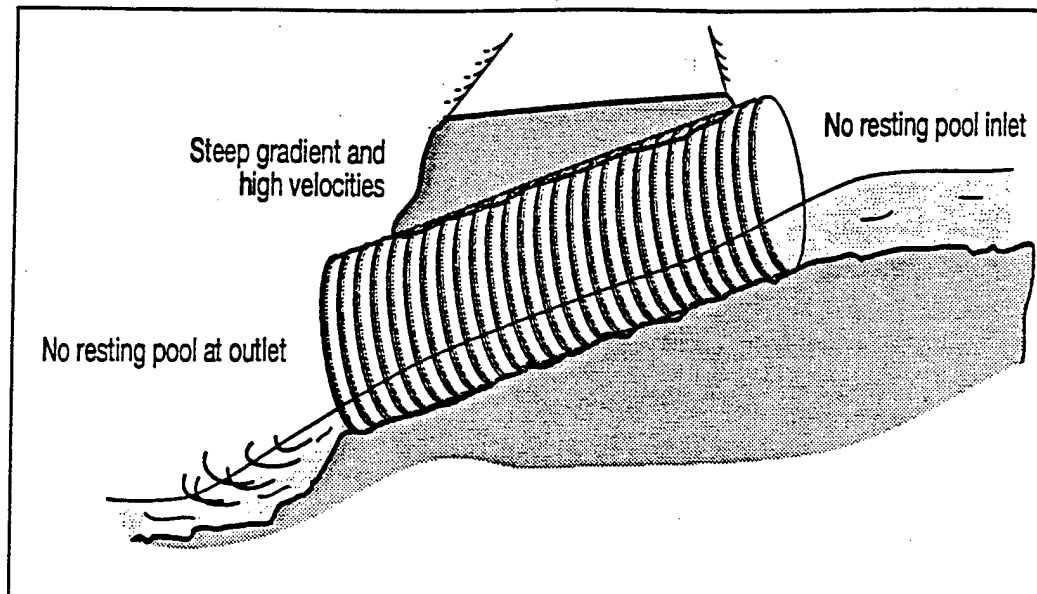
**Figure 16.** Culvert installations suitable for fish passage (top) and unsuitable for fish passage (bottom) (from Evans and Johnston, 1980).

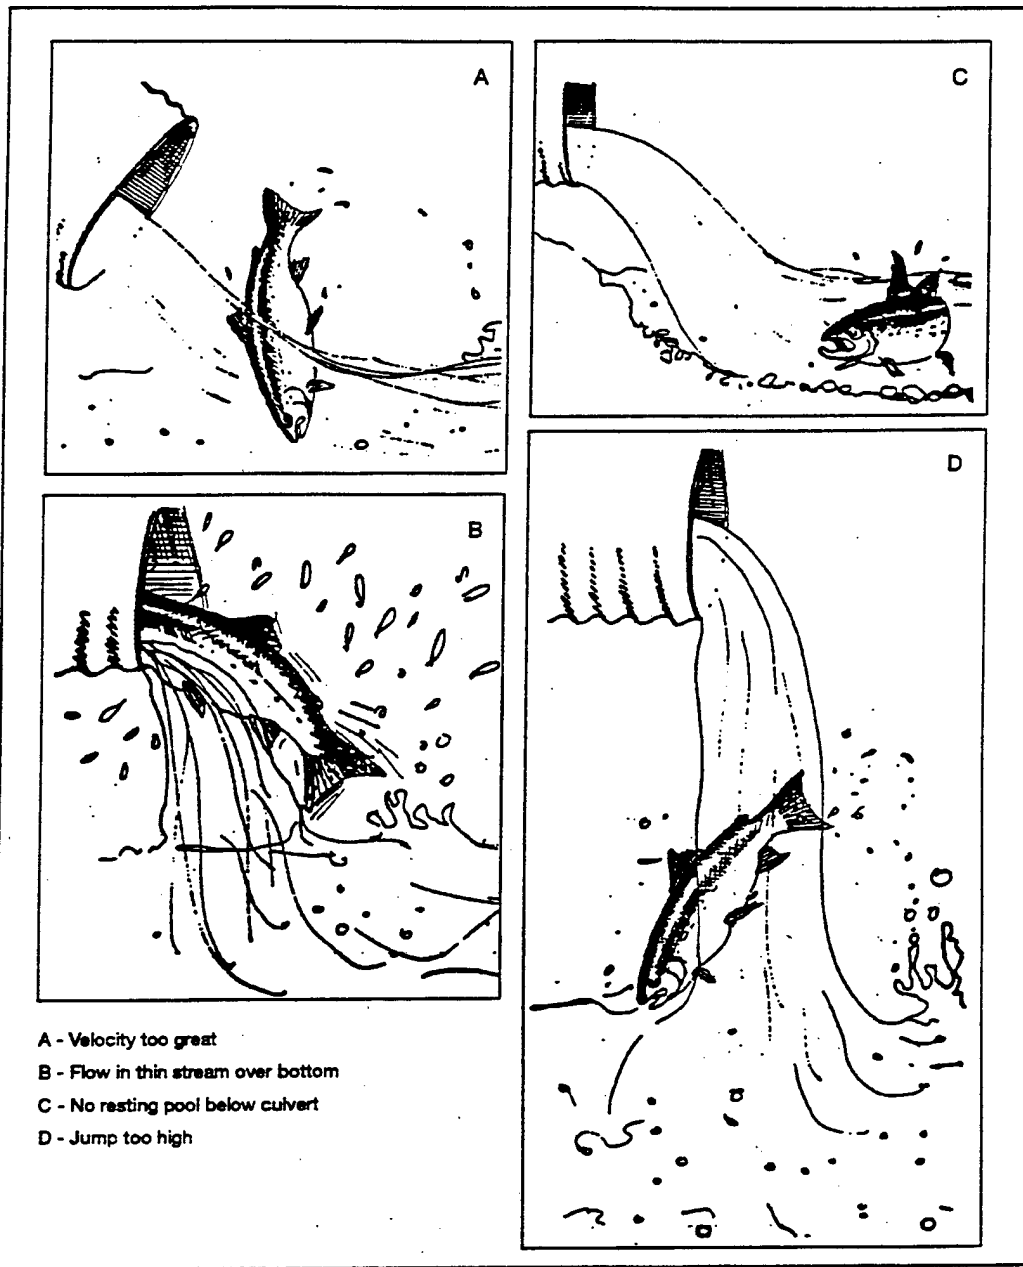
**Figure 17.** Common conditions that block fish passage (from Evans and Johnston, 1980).

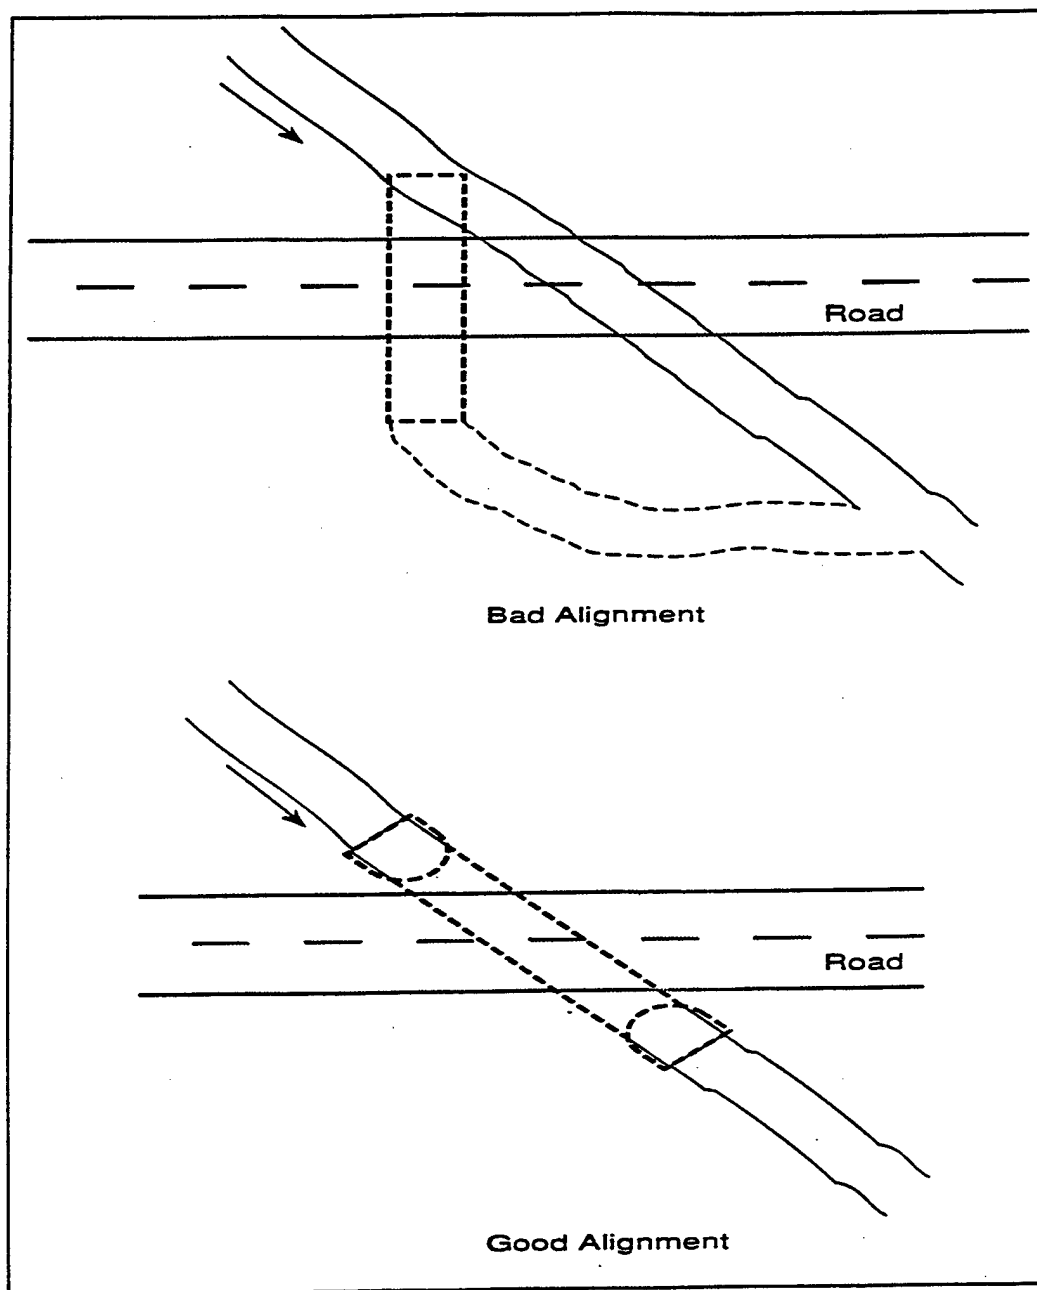
**Figure 18.** Locating culvert crossings (Baker and Votapka, 1990).

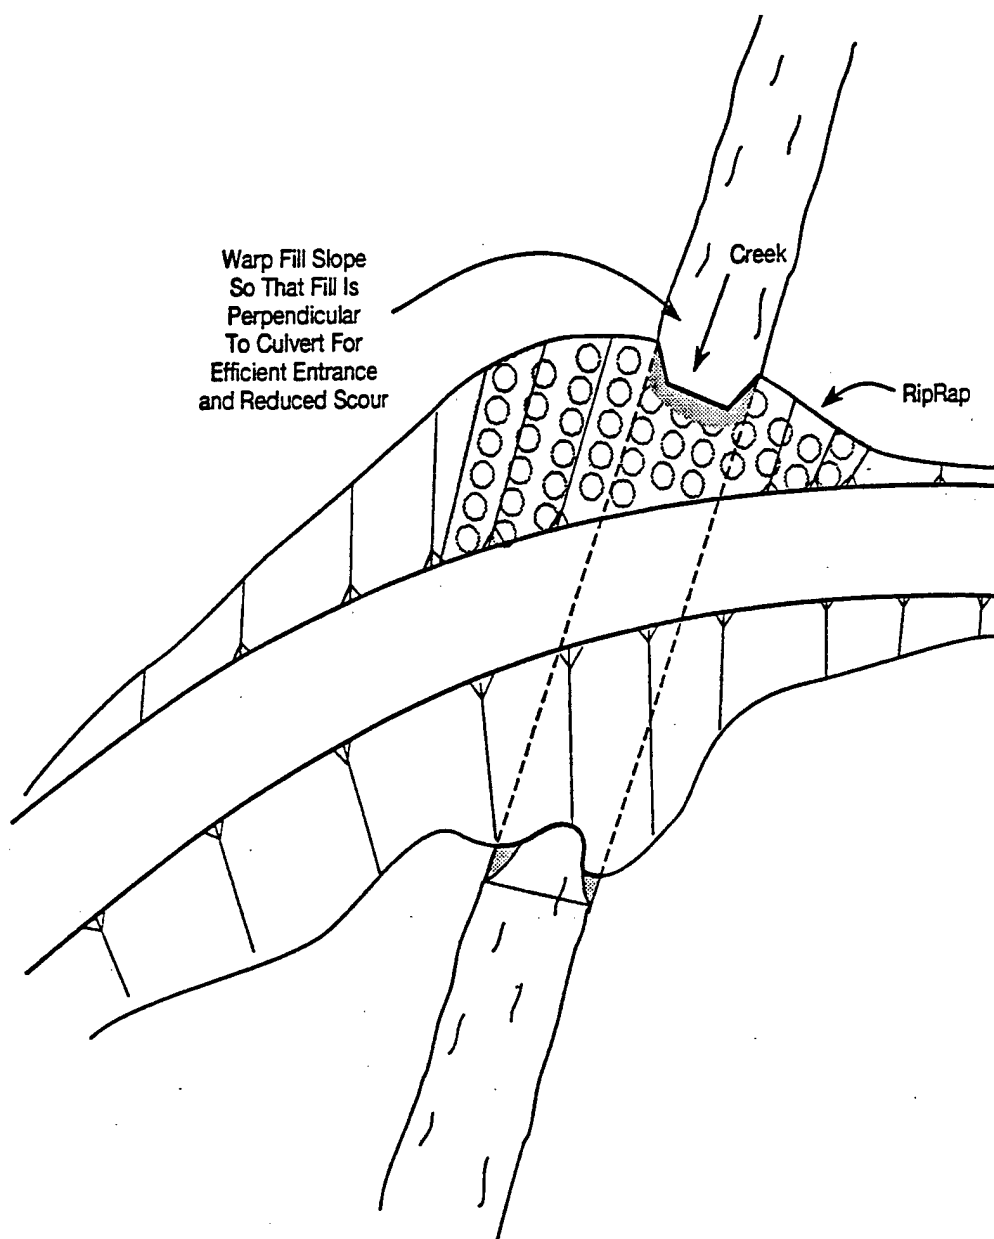
**Figure 19.** Typical section for warping fill slopes to increase hydraulic efficiency and to reduce scouring (Baker and Votapka, 1990).

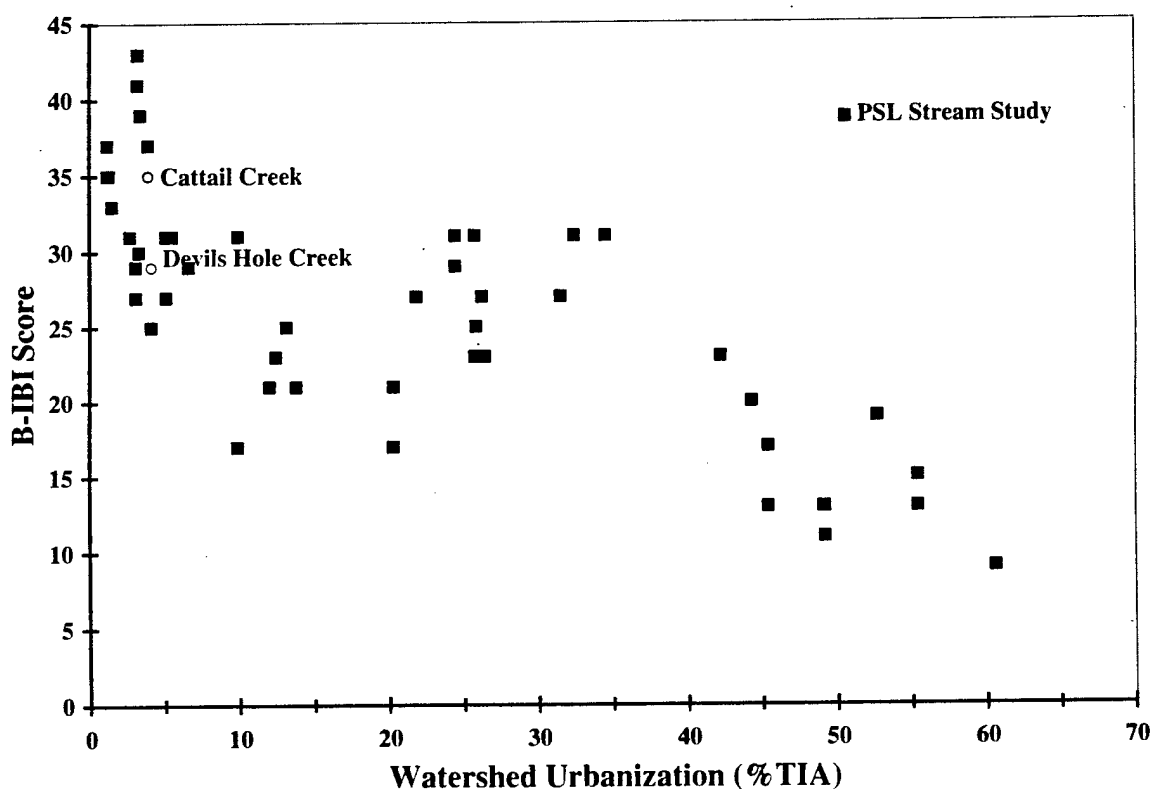
**Figure 20.** Biological integrity of Cattail Creek and Devils Hole Creek compared with results of the PSL stream study (May, 1996), as measured by the benthic index of biotic integrity (B-IBI). The higher the score, the better the biological integrity.

It is strongly recommended that a biological monitoring plan be established for the NSB. This plan should utilize benthic macroinvertebrates as the indicator organisms and should utilize a multimetric index for analysis. The benthic index of biotic integrity (B-IBI) developed by Karr (1996) for the PNW or the US EPA protocols (Plafkin, 1989) are recommended.

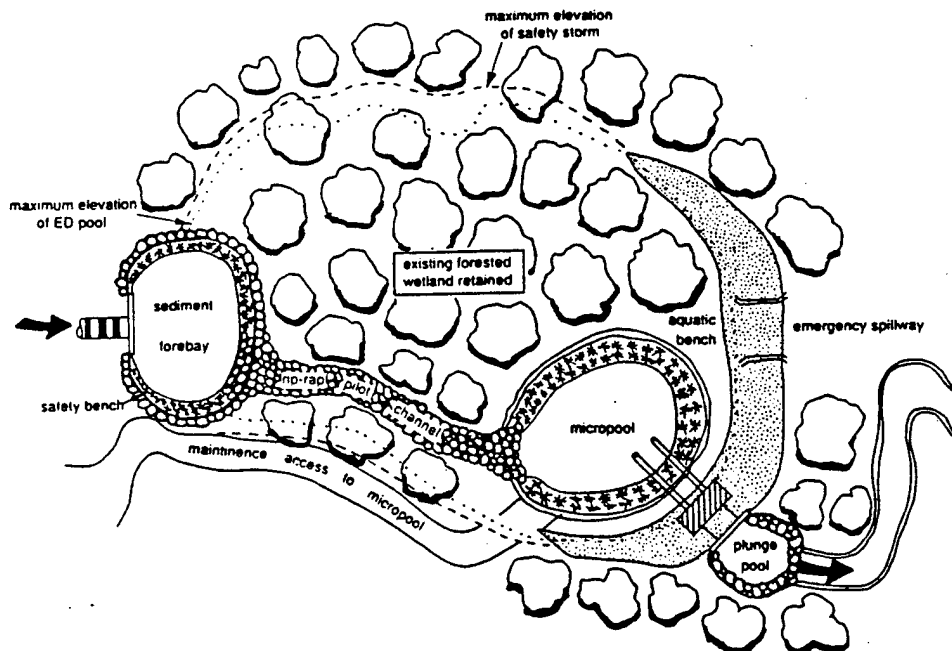
Figure 21. Enhanced extended detention (ED) dry pond.

These facilities (often referred to as “dry” ponds) temporarily detain a portion of the runoff from each storm for a period of time. ED ponds provide excellent stormwater quantity control if adequately sized. These ponds utilize a fixed-size outlet orifice to control the outflow rate and are sized in accordance with design criteria. These ponds are typically designed to contain stormwater for 48–72 hours. ED ponds often have a sediment-settling forebay to enhance their effectiveness and increase their longevity (Figure 21). Typical ED ponds provide moderate removal of particulates (the median removal rate for TSS is 61%)

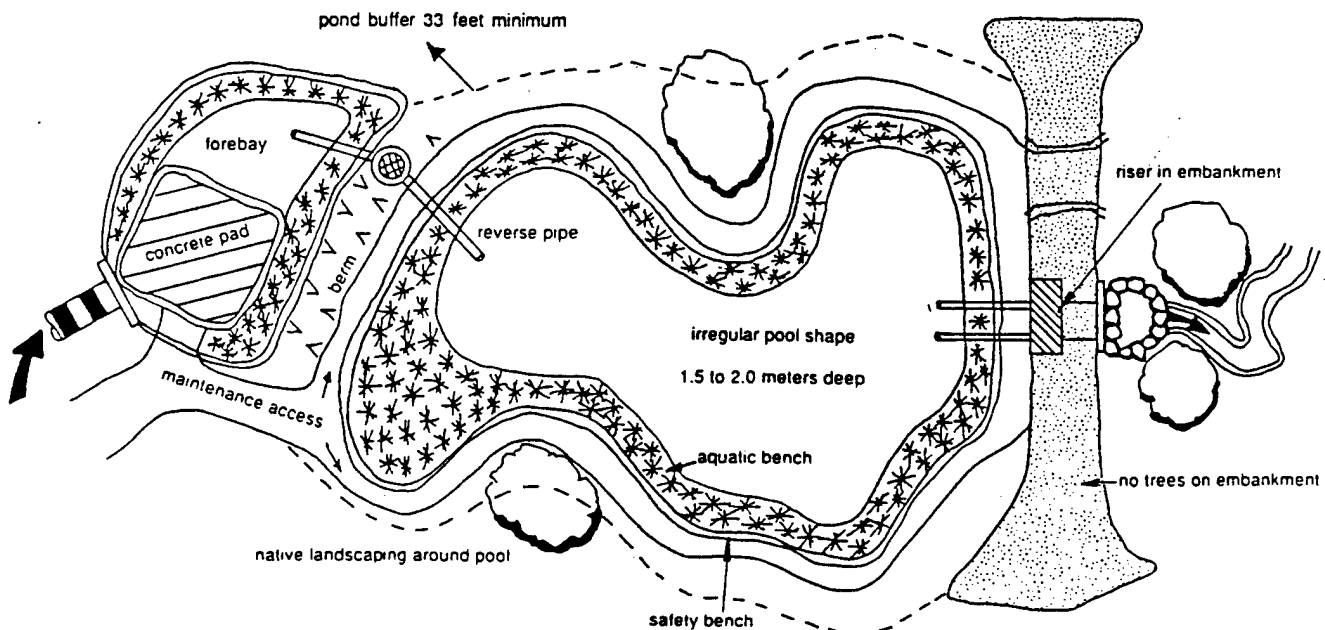
Figure 22. Enhanced wet pond.

These are the most common stormwater ponds and consist of a permanent pool or pools of water for treating incoming runoff. Pollutant-removal mechanisms include settling, plant uptake, and biological decomposition. These ponds can be enhanced by including a sediment-settling forebay (Figure 22). A conventional WP provides moderate to high removal of both particulate and soluble pollutants (the median removal rate for TSS is 77%). These ponds work best for larger developments (10 acres or more) and have a good overall long-term performance provided sediment is removed on a regular basis. A WP can require a large area and can have negative environmental effects (poor dry-season water quality, downstream warming, and groundwater contamination). The construction and maintenance costs of a WP facility are moderate. Wetland vegetation can be included in the WP design to enhance pollutant removal and habitat formation. A deep WP can be a hazard to local residents, and for this reason these facilities are normally fenced. An ED WP is similar to a conventional ED pond except that a permanent pool is incorporated into the design to provide less chance of sediment resuspension and outflow.

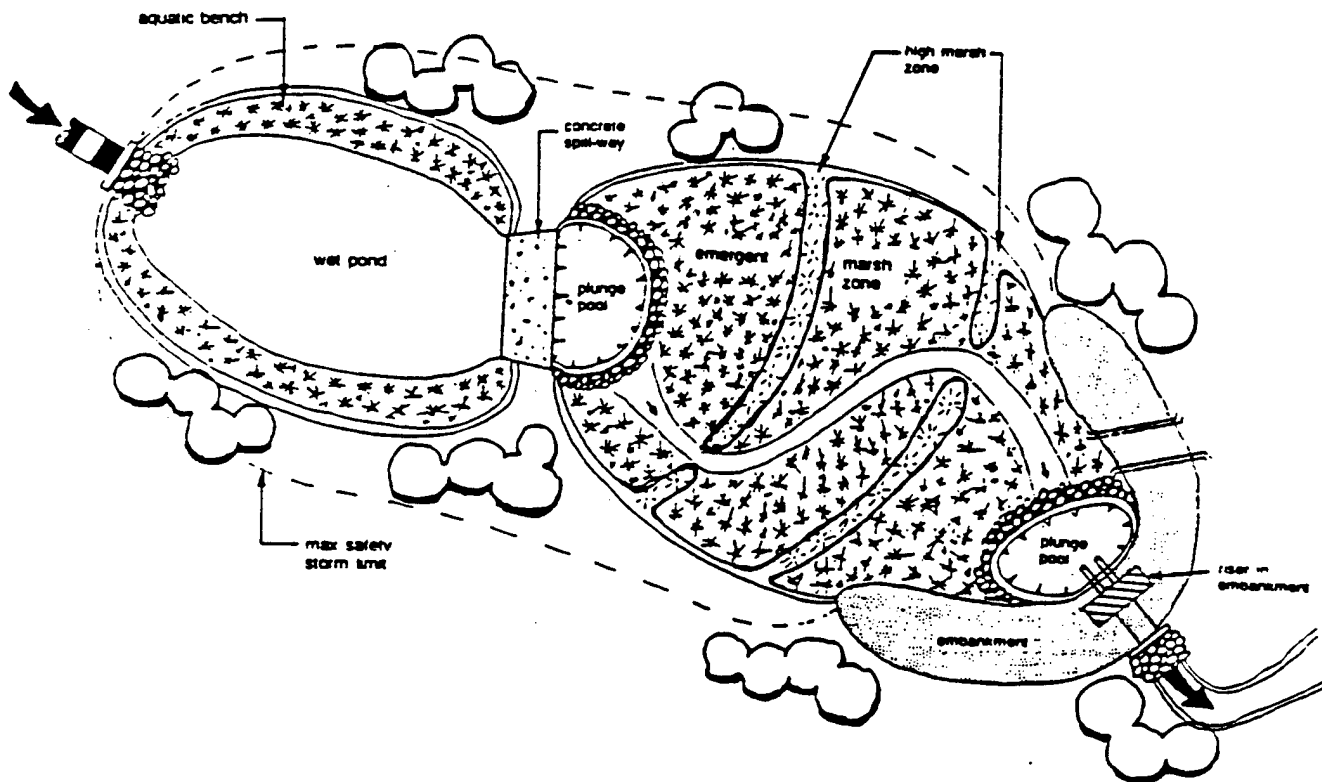
Figure 24. Combination pond and wetland system.

A combined pond/wetland system (Figure 24) can be very effective for both water quality treatment and quantity control. This "treatment-train" concept is becoming more common, in part because multiple treatment systems are more efficient at removing pollutants. Constructed wetlands may include design features that support natural wetland functions such as wildlife habitat. Construction and maintenance costs are comparable to those for conventional stormwater facilities. There are several types of stormwater (constructed) wetlands, including shallow marshes (Figure 25), pocket wetlands (Figure 26), and ED wetlands (Figure 27). Older stormwater basins can also be retrofitted with wetland features. Guidelines for selecting the type of constructed wetland to use for stormwater treatment are shown in Table 7.

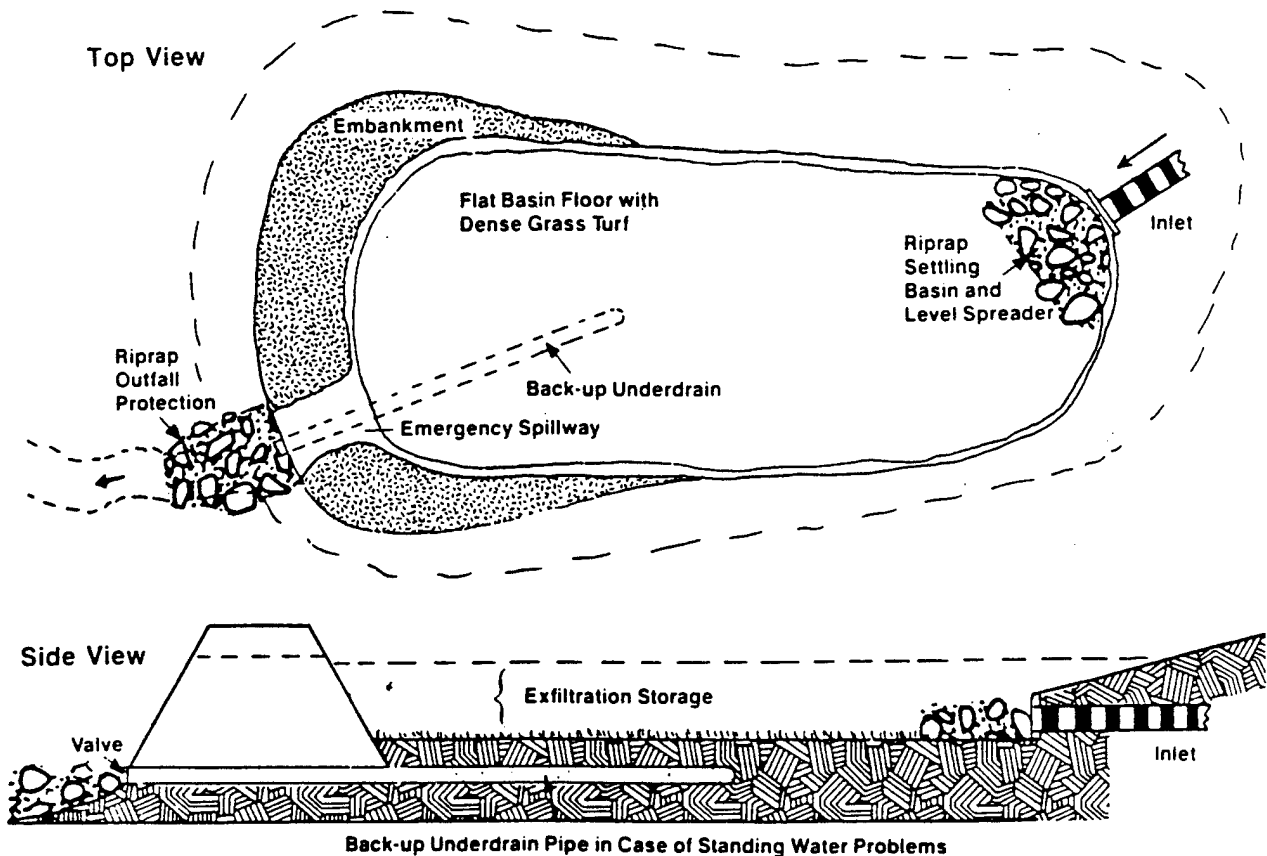
Figure 28. Infiltration basin.

An infiltration basin, or retention pond, is shown in Figure 28. Infiltration trenches (Figure 29) are small trenches that have been backfilled with gravel and sand. They are commonly used at the downslope edge of parking lots or other impervious surface areas. Infiltration swales (Figure 30) can also be constructed as part of an in-line stormwater treatment system. Few data are available on the performance or longevity of infiltration basins or trenches. These facilities are generally more costly to construct and maintain than conventional stormwater detention facilities.

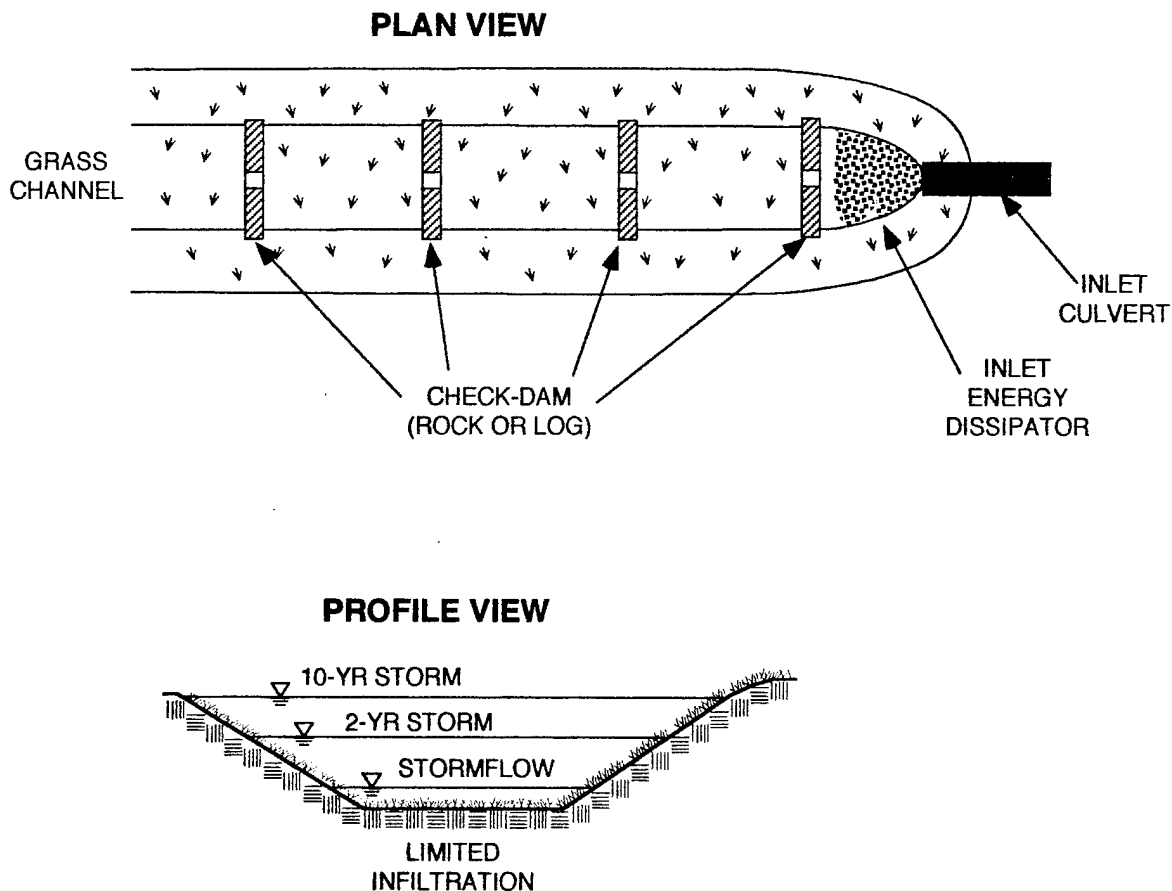
Figure 31. Biofiltration swale.

Biofiltration swales are vegetated channels designed to filter incoming stormwater which is directed into them as sheet flow. Check dams are often utilized to increase stormwater detention and enhance swale effectiveness. Biofiltration swales can be designed as dry or wet systems, depending on the hydrogeologic conditions and site requirements. Figure 31 shows a dry biofiltration swale, and Figure 32 a wet swale. Filter strips (Figure 33) are designed to be dry systems except during storms. Filter strips are vegetated sections of land designed to accept runoff as sheet flow. Grasses and wetland vegetation are appropriate for all these facilities. Such facilities can be quite effective in removing stormwater pollutants from small, nonindustrial areas (the median removal rate for TSS is 81%) and have been shown to work best in residential areas. Filter strips can be incorporated into riparian buffers along streams or wetlands and can serve as a transition from lawns to riparian forest zones (they should not be considered a replacement for riparian buffers). Construction and maintenance costs are relatively low.

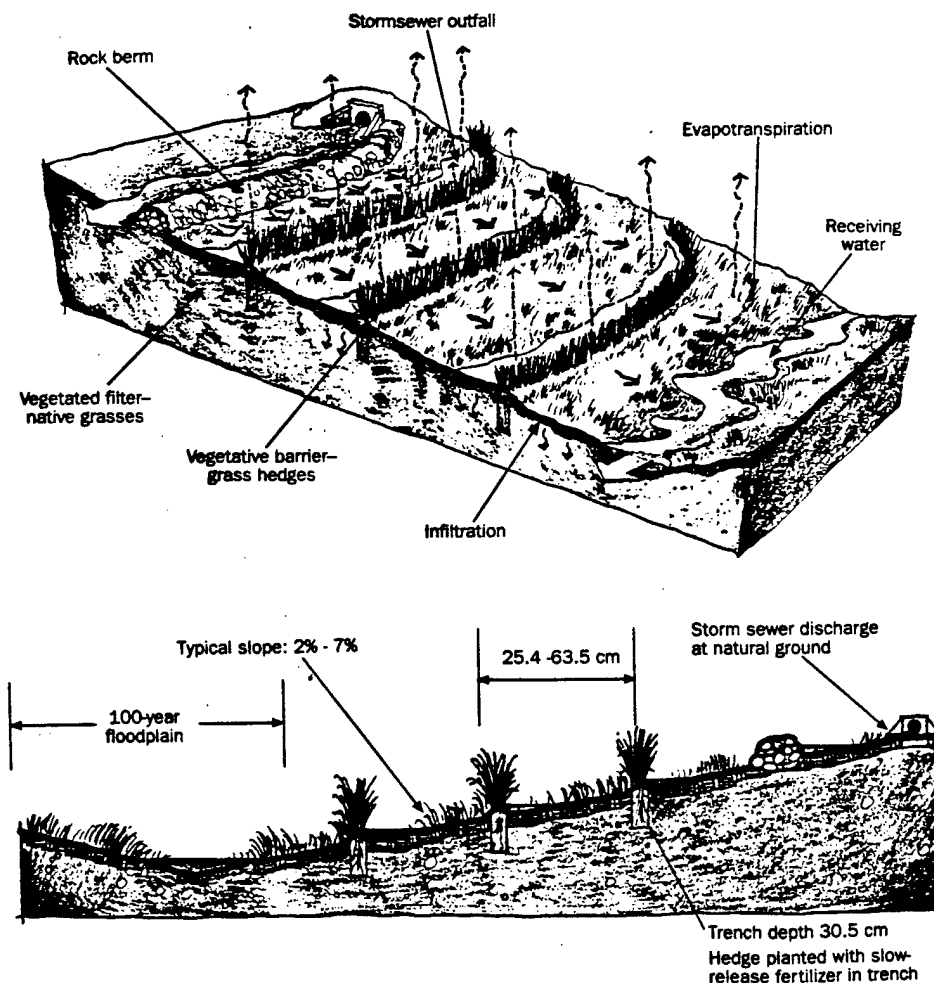
Figure 34. Typical biodetention system.

This is a new technique developed as a cost-effective alternative to detention ponds that is applicable to sloped sites (Murfee et al., 1997). This innovative method capitalizes on the proven effectiveness of several conventional BMPs. Biodetention utilizes multiple treatment mechanisms, including screening of larger particulates, vegetative filtering of smaller particulates, sedimentation, and infiltration. Figure 34 shows a typical biodetention system. A rock berm at the head of the facility screens coarse particulates and debris. This berm also serves to disperse the channelized inflow into a more dispersed sheet flow. The stormwater then flows downslope through several alternating vegetated filter strips and vegetative barriers. The filter strips remove pollutants by sedimentation, filtration, uptake, and microbial degradation. The vegetative barriers are narrow strips of coarse perennial vegetation established along the contour of the slope to detain stormwater and maintain sheet flow as the runoff flows downslope. As a BMP system, biodetention has been used in only a few cases; the components are proven techniques.
